## Technical Notes

# Finding a hidden miss in a Packard was a several hours long process

By Paul Rydning

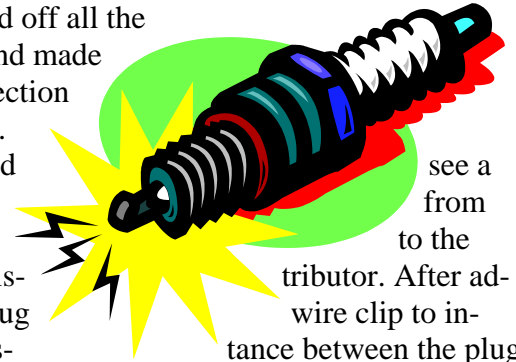
I now could see a spark jump from the #4 plug base of the distributor. After adjusting the plug wire clip to increase the distance between the plug and the distributor I restarted the engine and found I still had an intermittent miss which was especially pronounced when I opened the throttle. When I again tried the 12 volt test I found that my miss had disappeared.

With this in mind I removed the plugs and rechecked the plug gap. I found that I had gapped them at .032" as opposed to the factory recommended .025". I reinstalled them and found that my miss had disappeared!
