# Technical Notes: 1932 Ninth & 1933 Tenth Series Packards

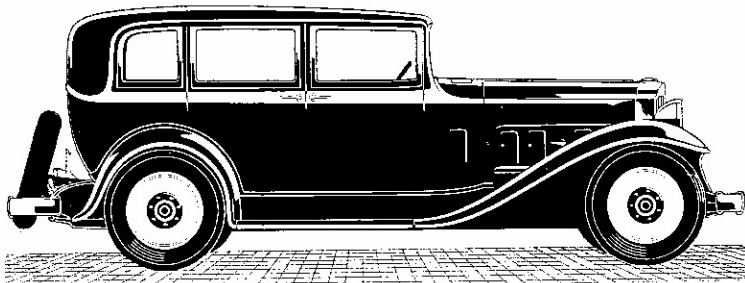
Here's what Packard said about one motorist with a 901 sedan: When unusual wear is found, it is caused by something other than the way the car was built, because exceptionally long life was built into every motor. The cylinder block and pistons from a 901 sedan were removed after 6,862 miles. The cylinders averaged almost .005" wear which is more than should have developed in 50,000 miles. Nothing in the design of the motor could have been responsible for this. The air cleaner shows no evidence of having been cleaned or oiled in the 8 months the car had been in ser-

A 1932 901 Packard Sedan

vice. It was perfectly dry and almost filled with dirt. The car had been driven under extremely bad dust conditions, but the neglect of the air cleaner produced a result which will always occur after a period of service, depending upon the amount of dust encountered. One must watch in particular the cars which encounter a great deal of dust.

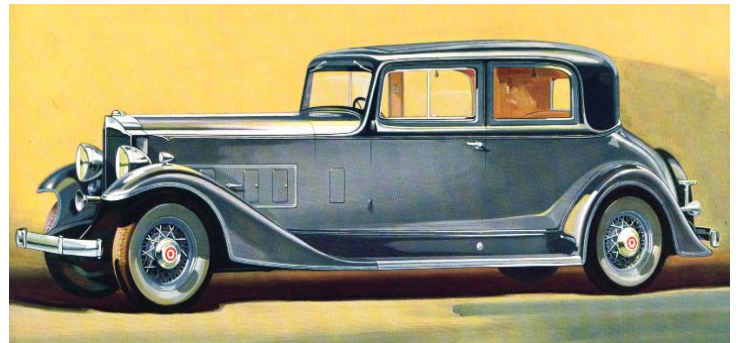
A 1933 1004 Super Eight Packard

## *ard which cuts out at high speed, what do you think is happening?*

This cutting out is probably caused by lack of fuel pump pressure or starving for fuel.

First be sure that all fuel line connections are tight and free from air leaks, both between the tank and the fuel pump and the fuel pump and the carburetor. Second see that the later type heavier spring is installed in the fuel pump to bring the pressure up to normal. If it still misses at high speed in hot weather, get the cross over tail pipe as far away from the gasoline tank as possible so that the tank will not absorb any more heat than is necessary.

If the condition still exists, it will be necessary to cut the cross section, running in front of the gasoline tank, out of the tail pipe, and weld the extreme end of the tail pipe to the section coming out of the muffler. This, of course, will give you a straight tail pipe at the right end of the tank instead of the left. Reconstructing the tail pipe will only be necessary in very extreme cases.

It may be necessary in some cases to flatten the end of the tail pipe more in order to get sufficient clearance where the pipe goes between the right end of the gasoline tank and the right rear spring shackle. Be sure to keep the pipe as far away from the end of the gasoline tank as possible.
